TECHNICAL INSPECTION REPORT
CONFIDENTIAL

U.S. S. SALT LAKE CITY (CCA 25)

VOLUME 2 OF 2

OPERATION CROSSROADS

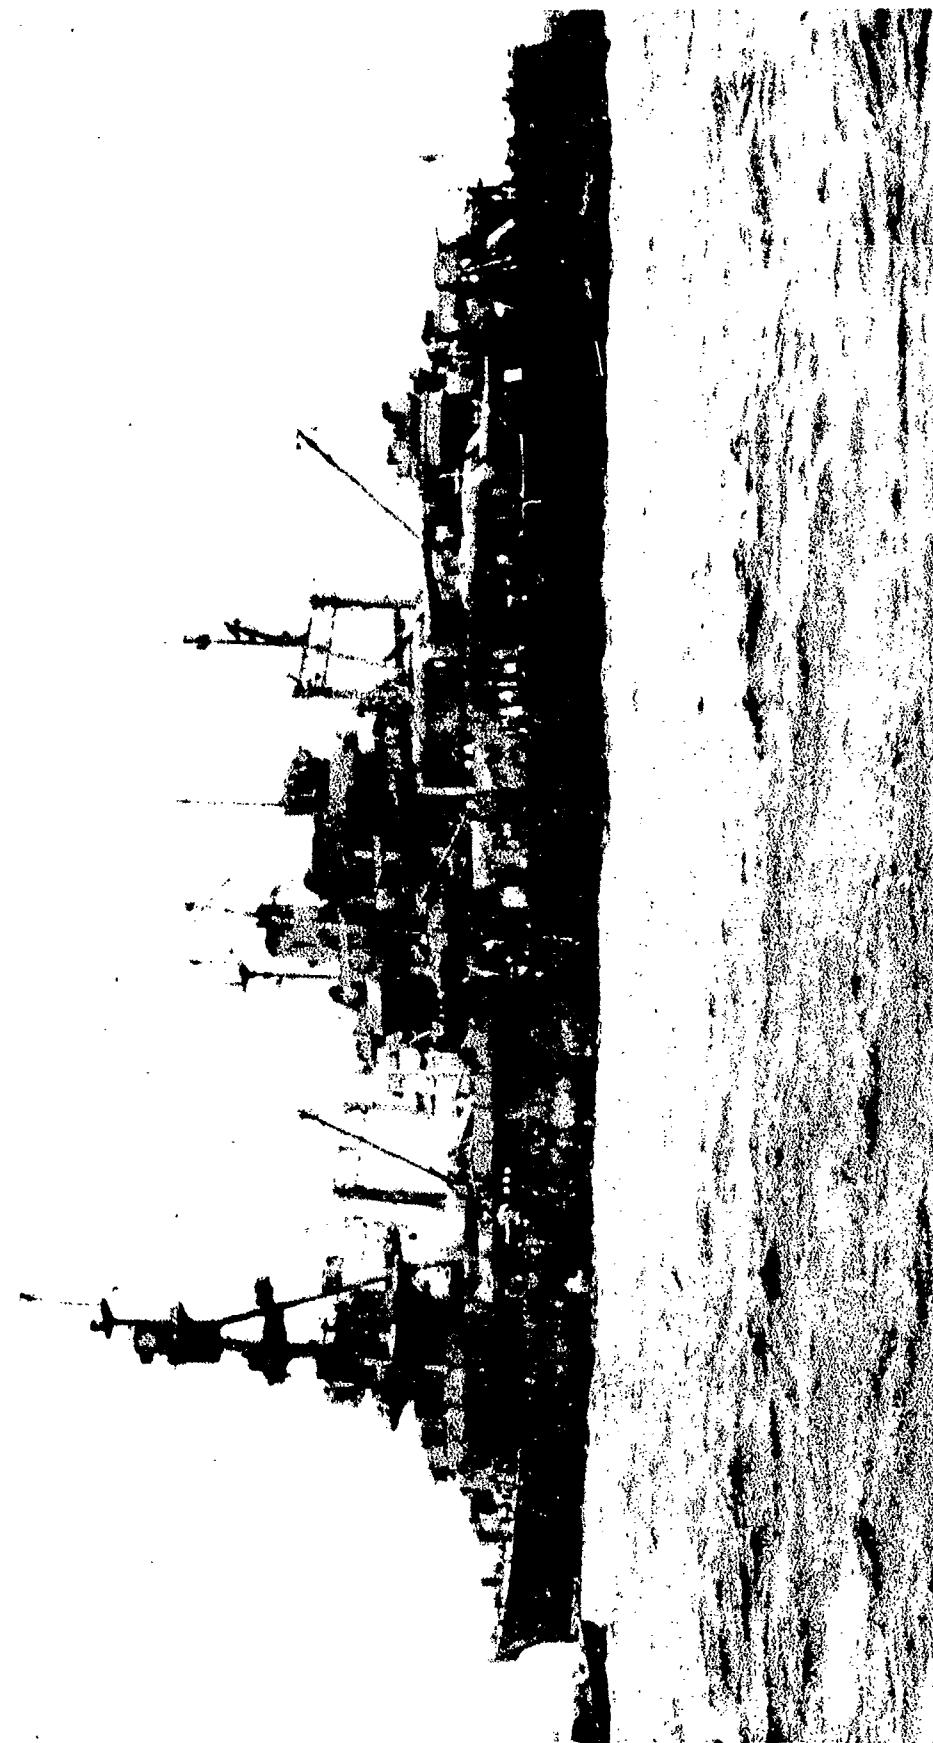
AA-CR-227-50-114. View from off port quarter after Test A.

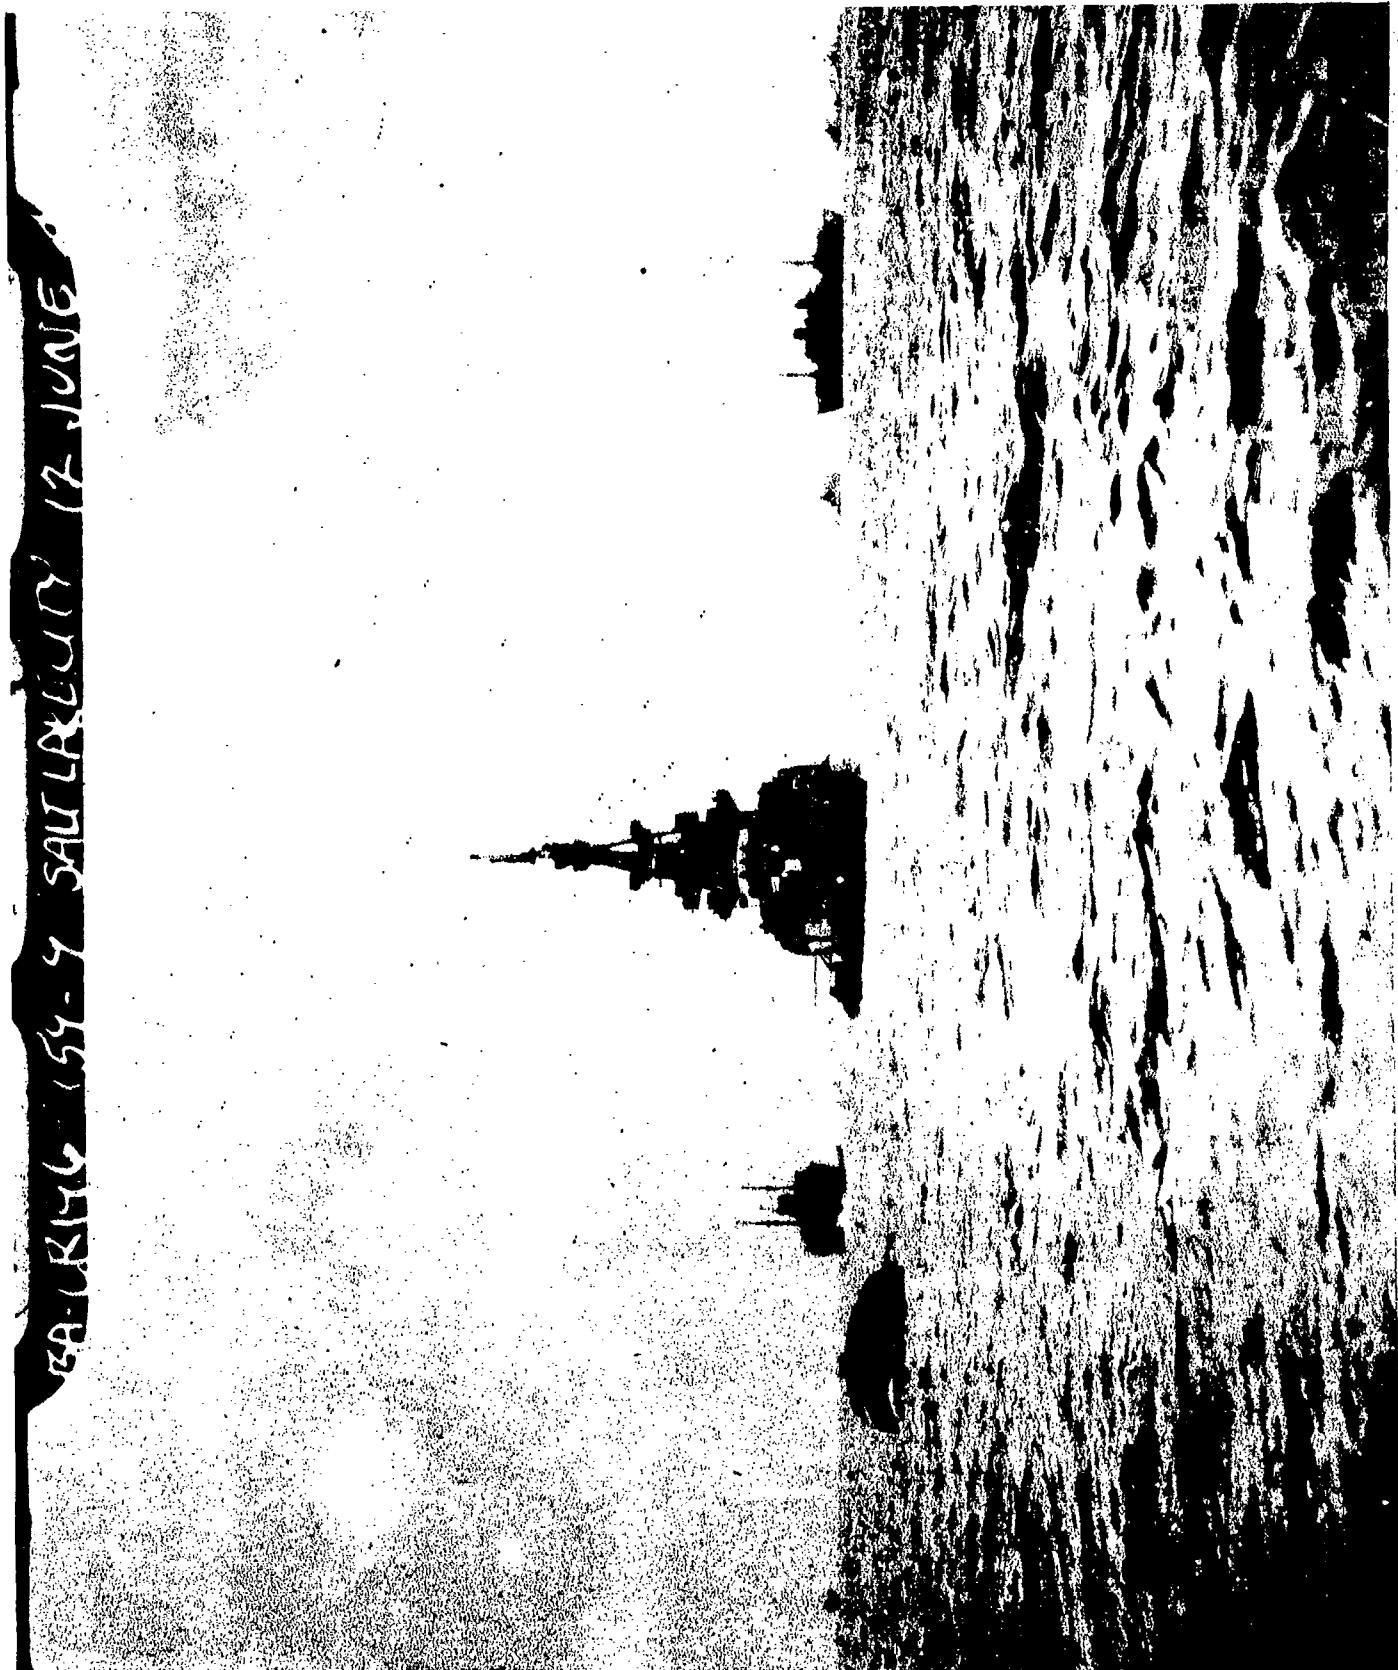
BA-CR-196-159-9. View from dead astern before Test A.

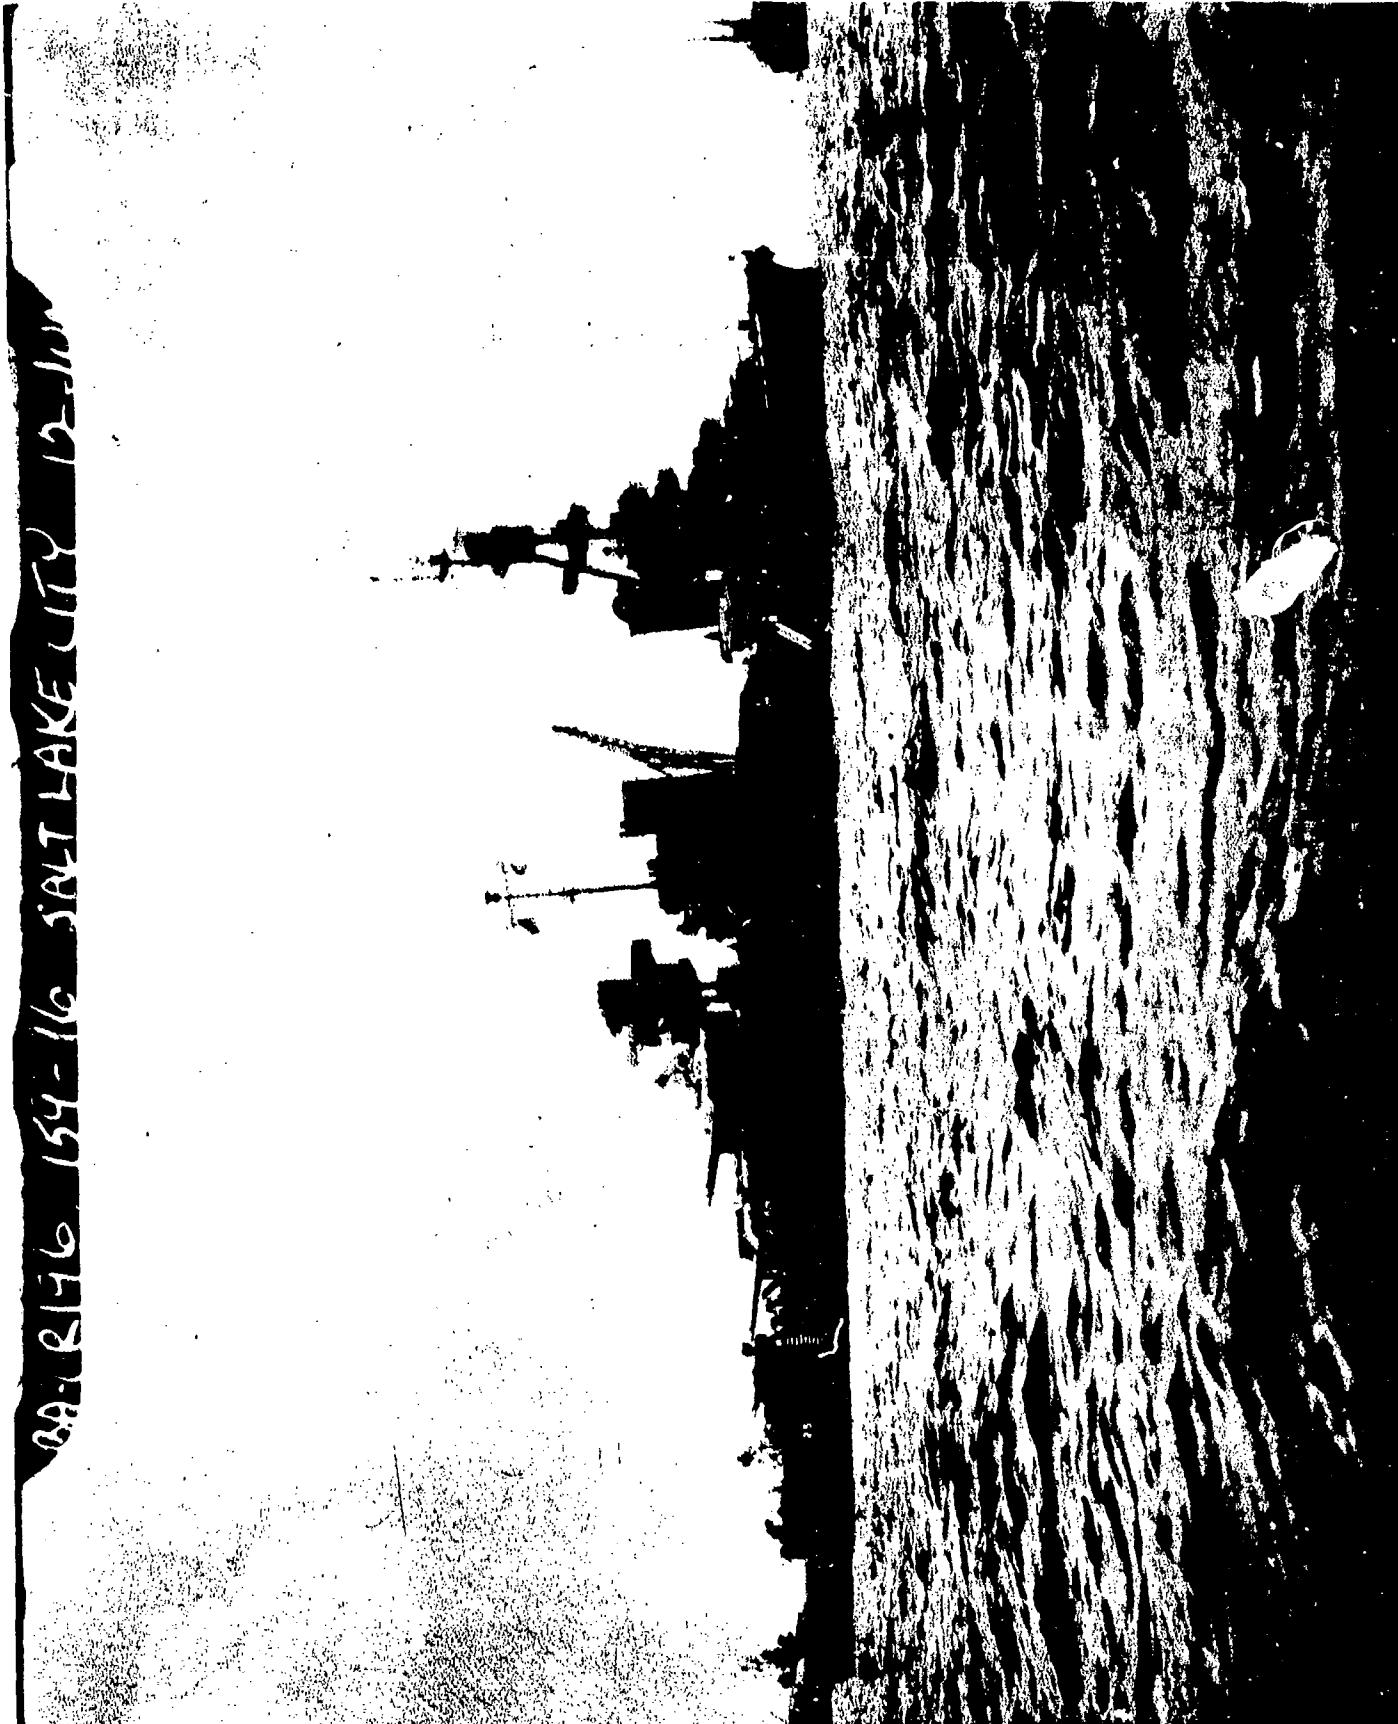
BA-CR-196-159-16. View from off starboard quarter before Test A.

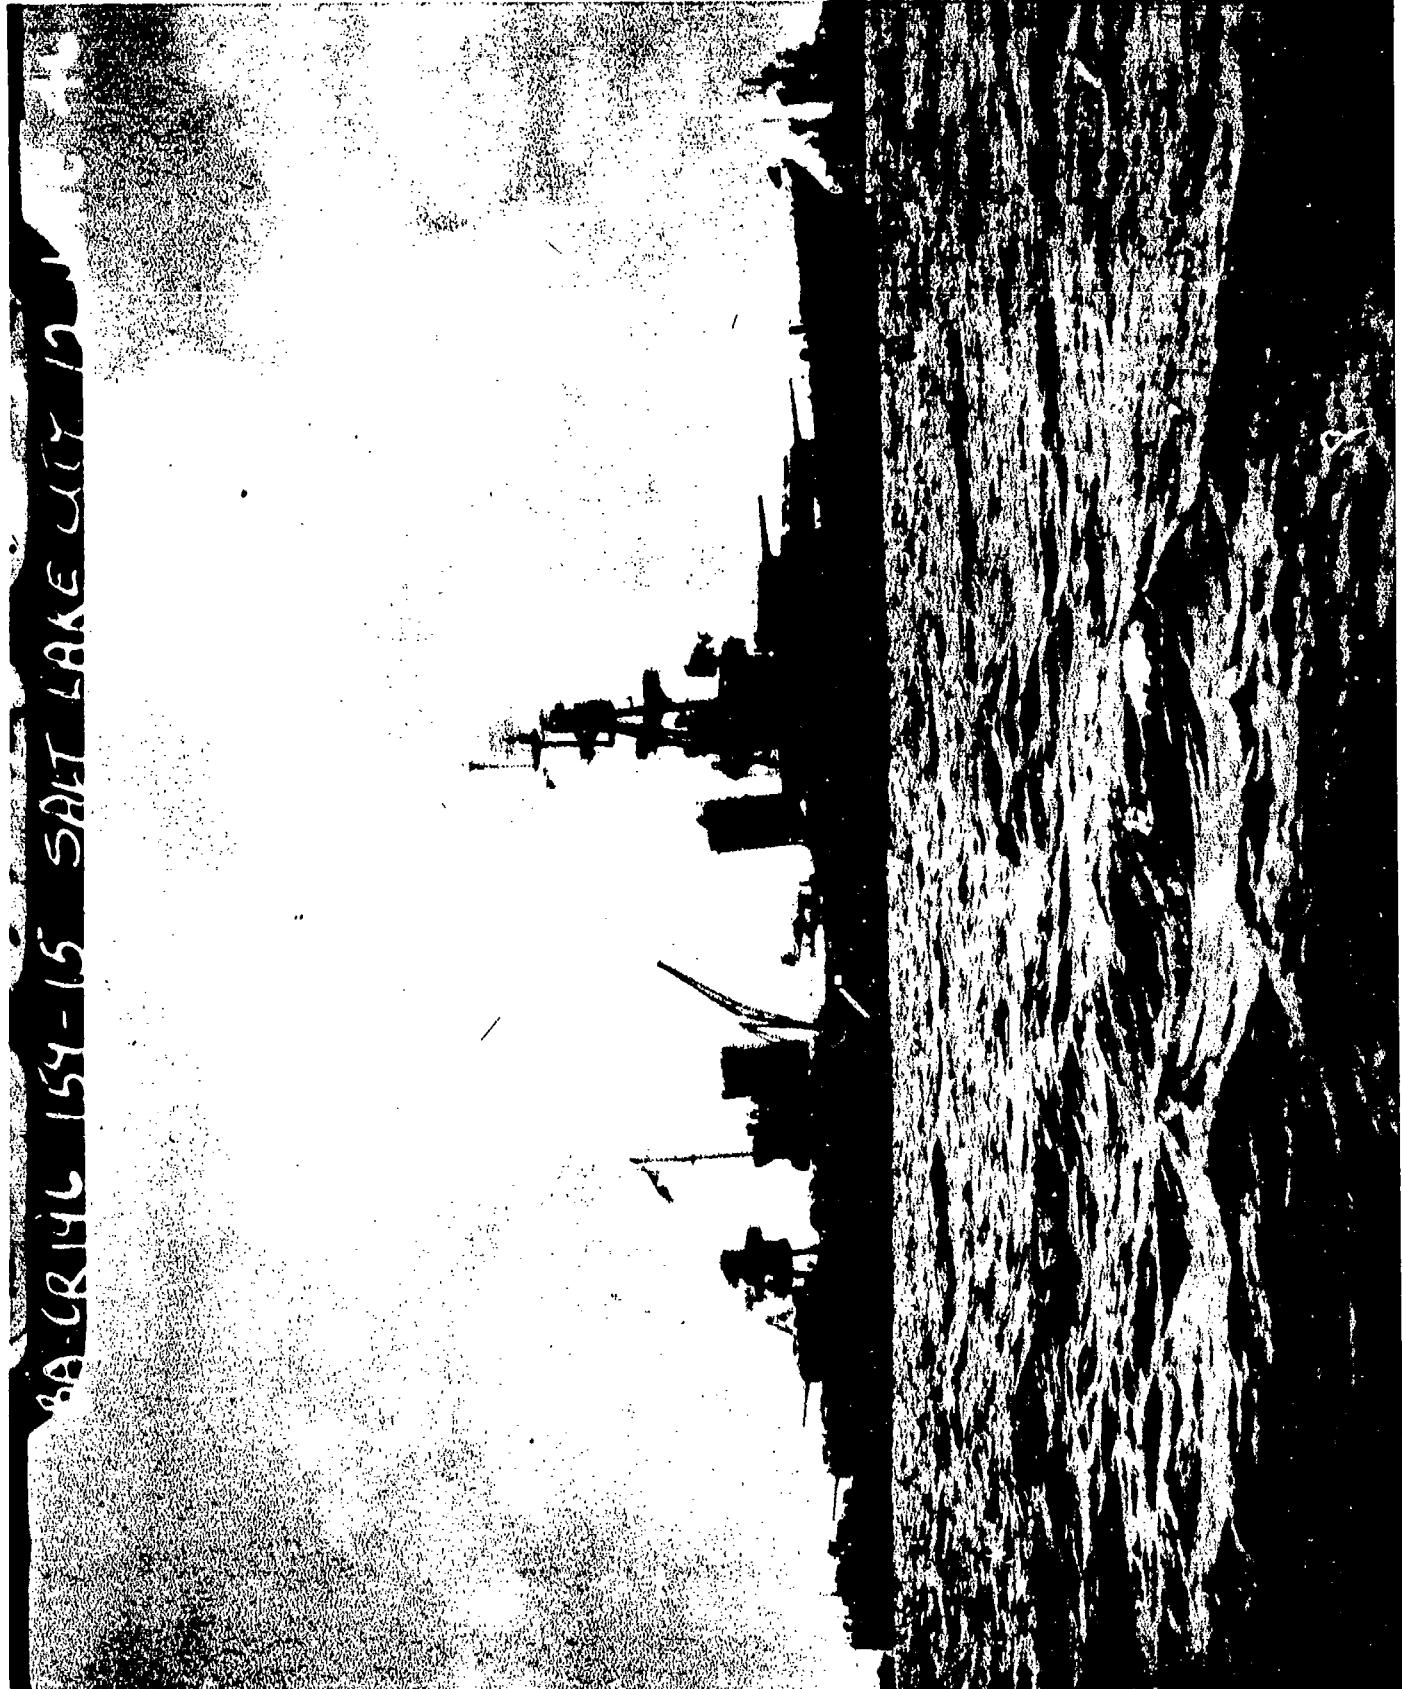
BA-CR-196-159-15. View from off starboard beam before Test A.

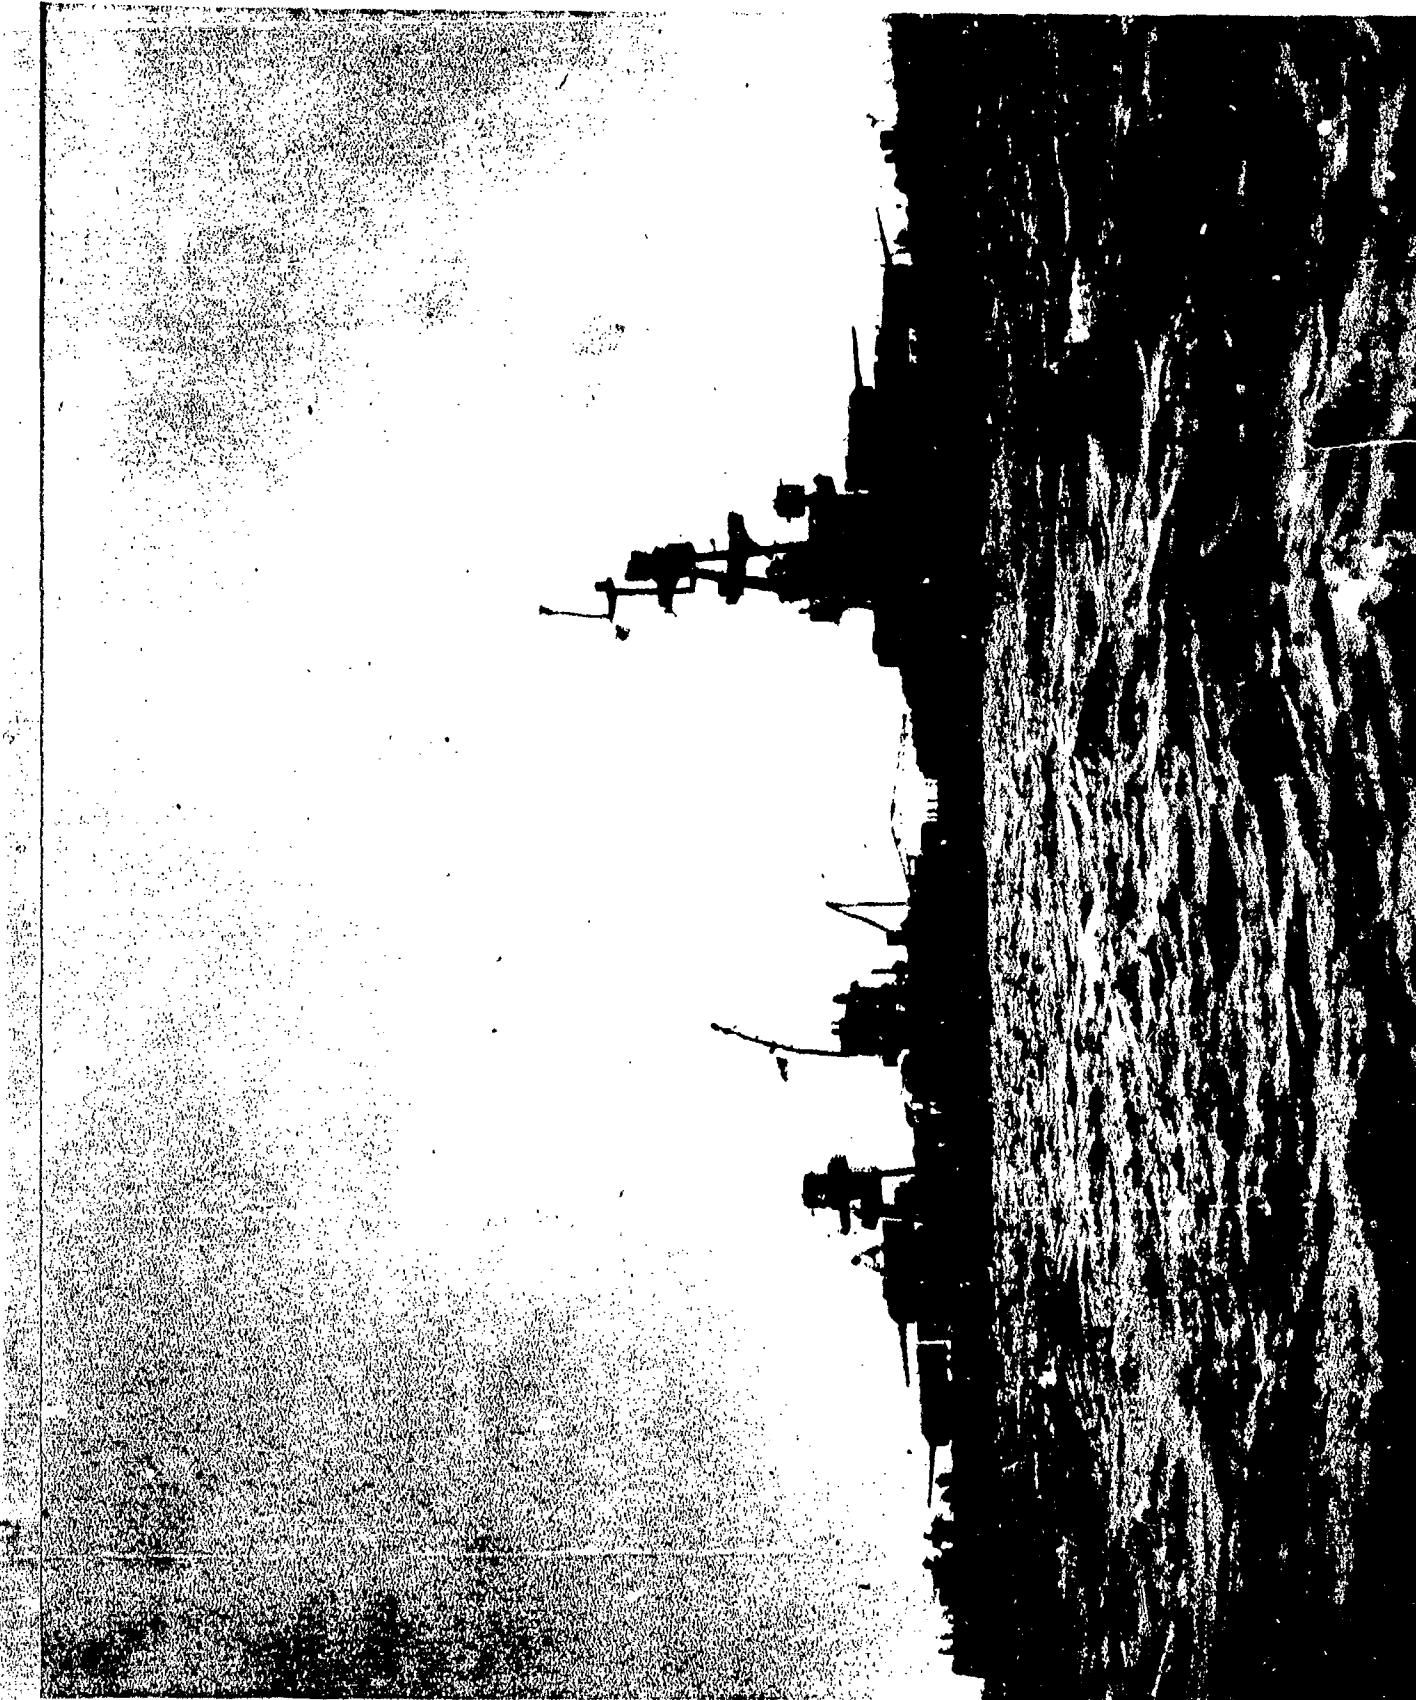
AA-CR-227-91-47. View from off starboard beam after Test A.

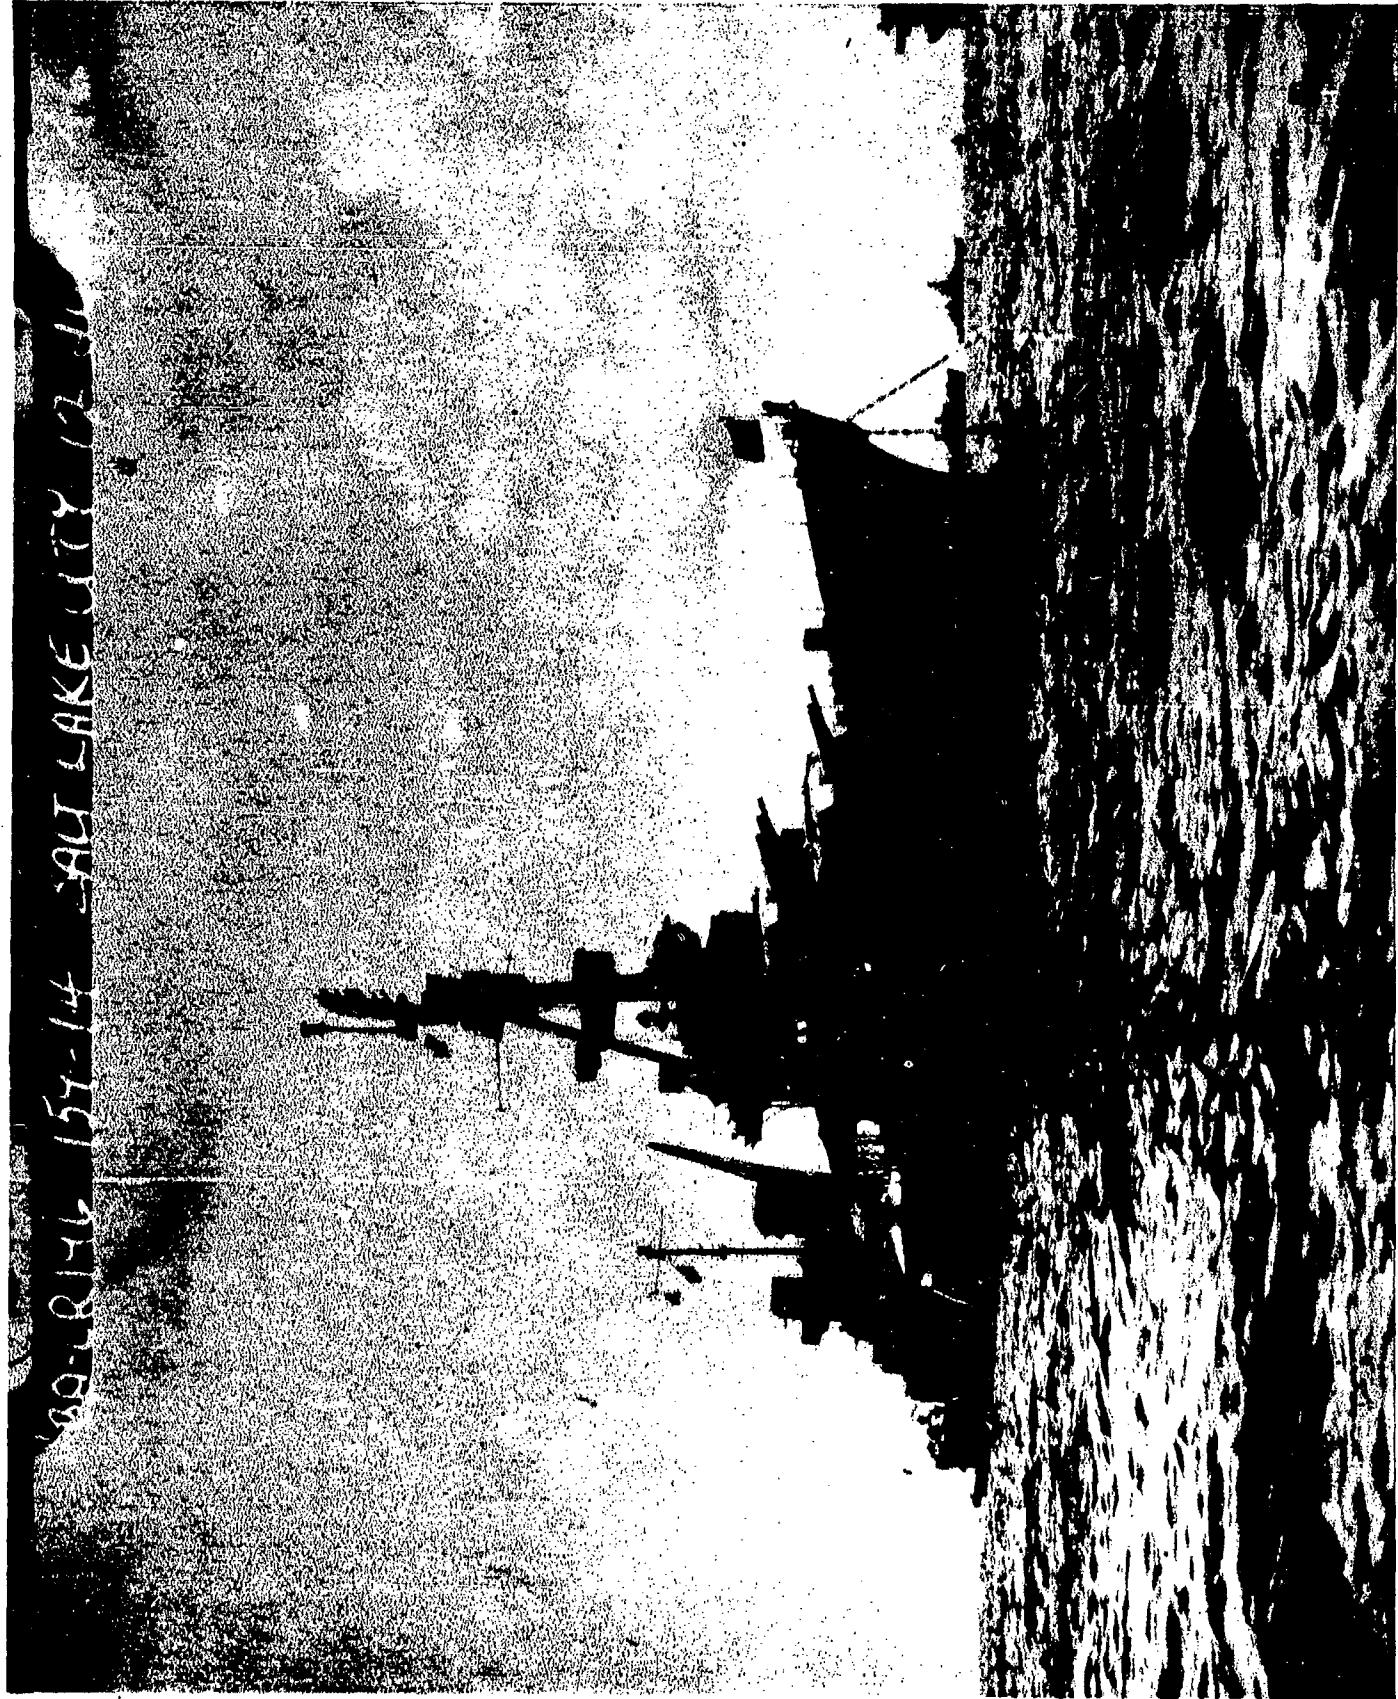
BA-CR-196-159-14. View from off starboard bow before Test A.

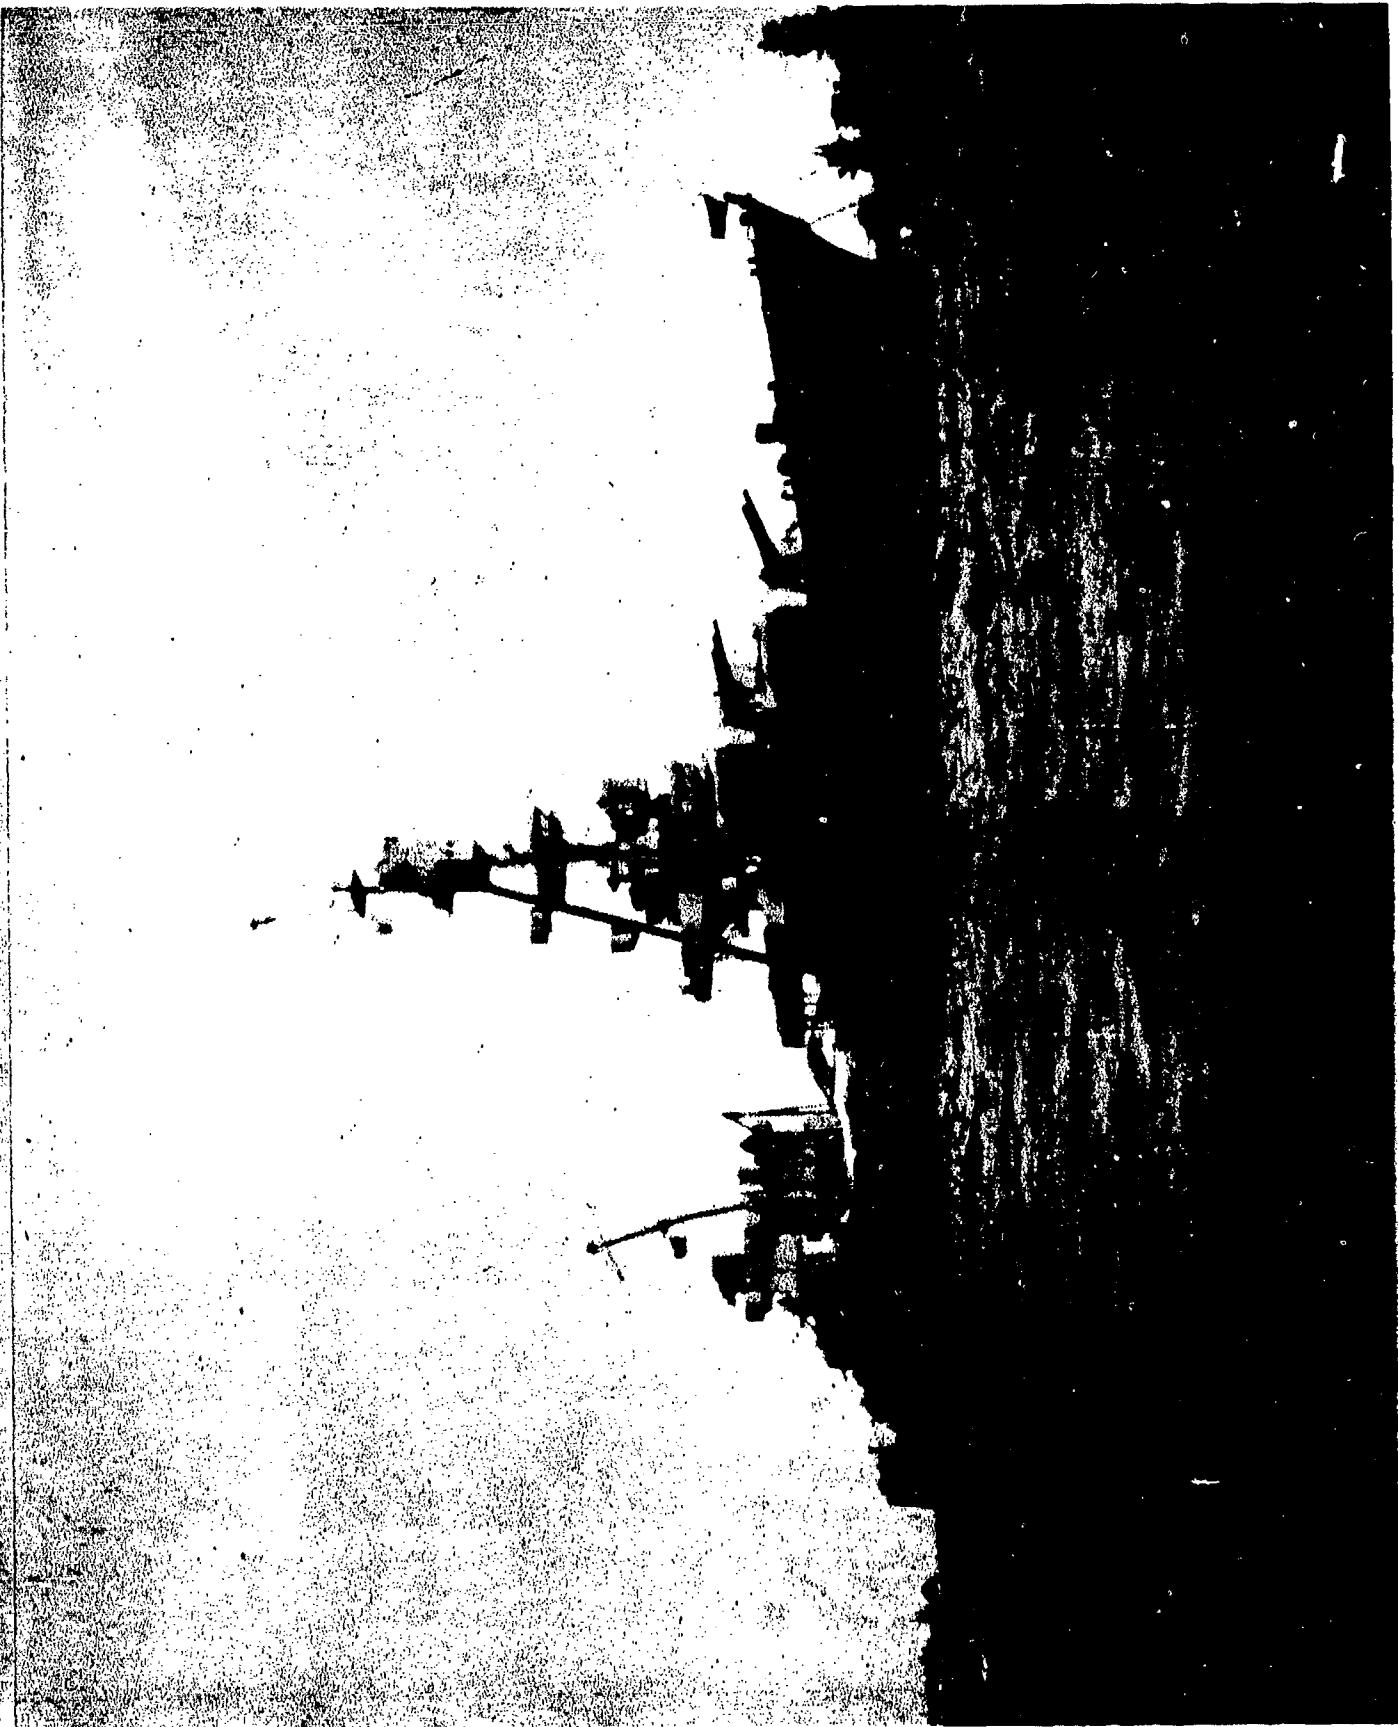
AA-CR-227-91-48. View from off starboard bow after Test A.

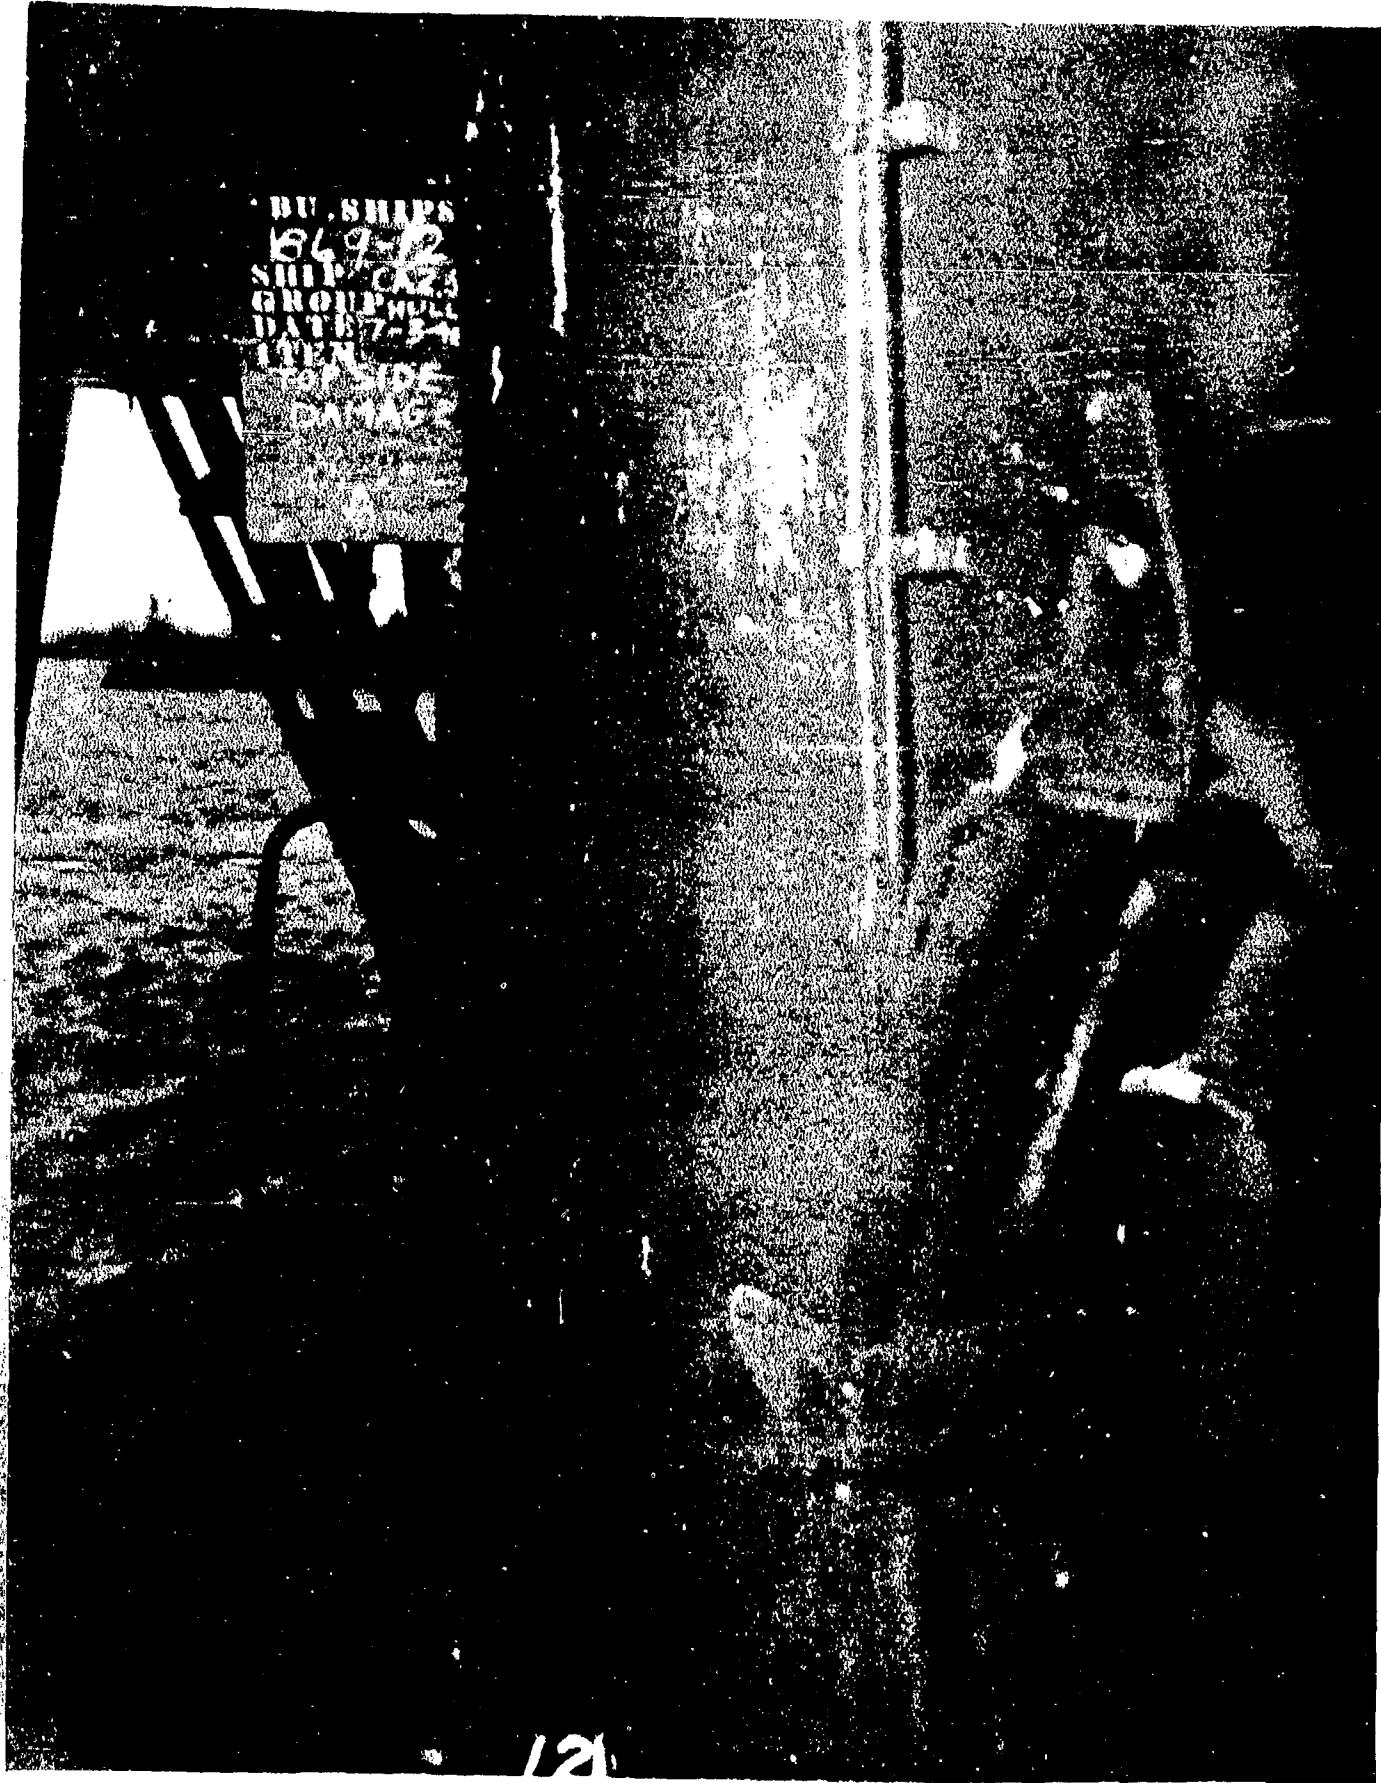
AA-CR-62-1869-12. Looking to port at after corner of plotting room, emergency platform, frame 48.

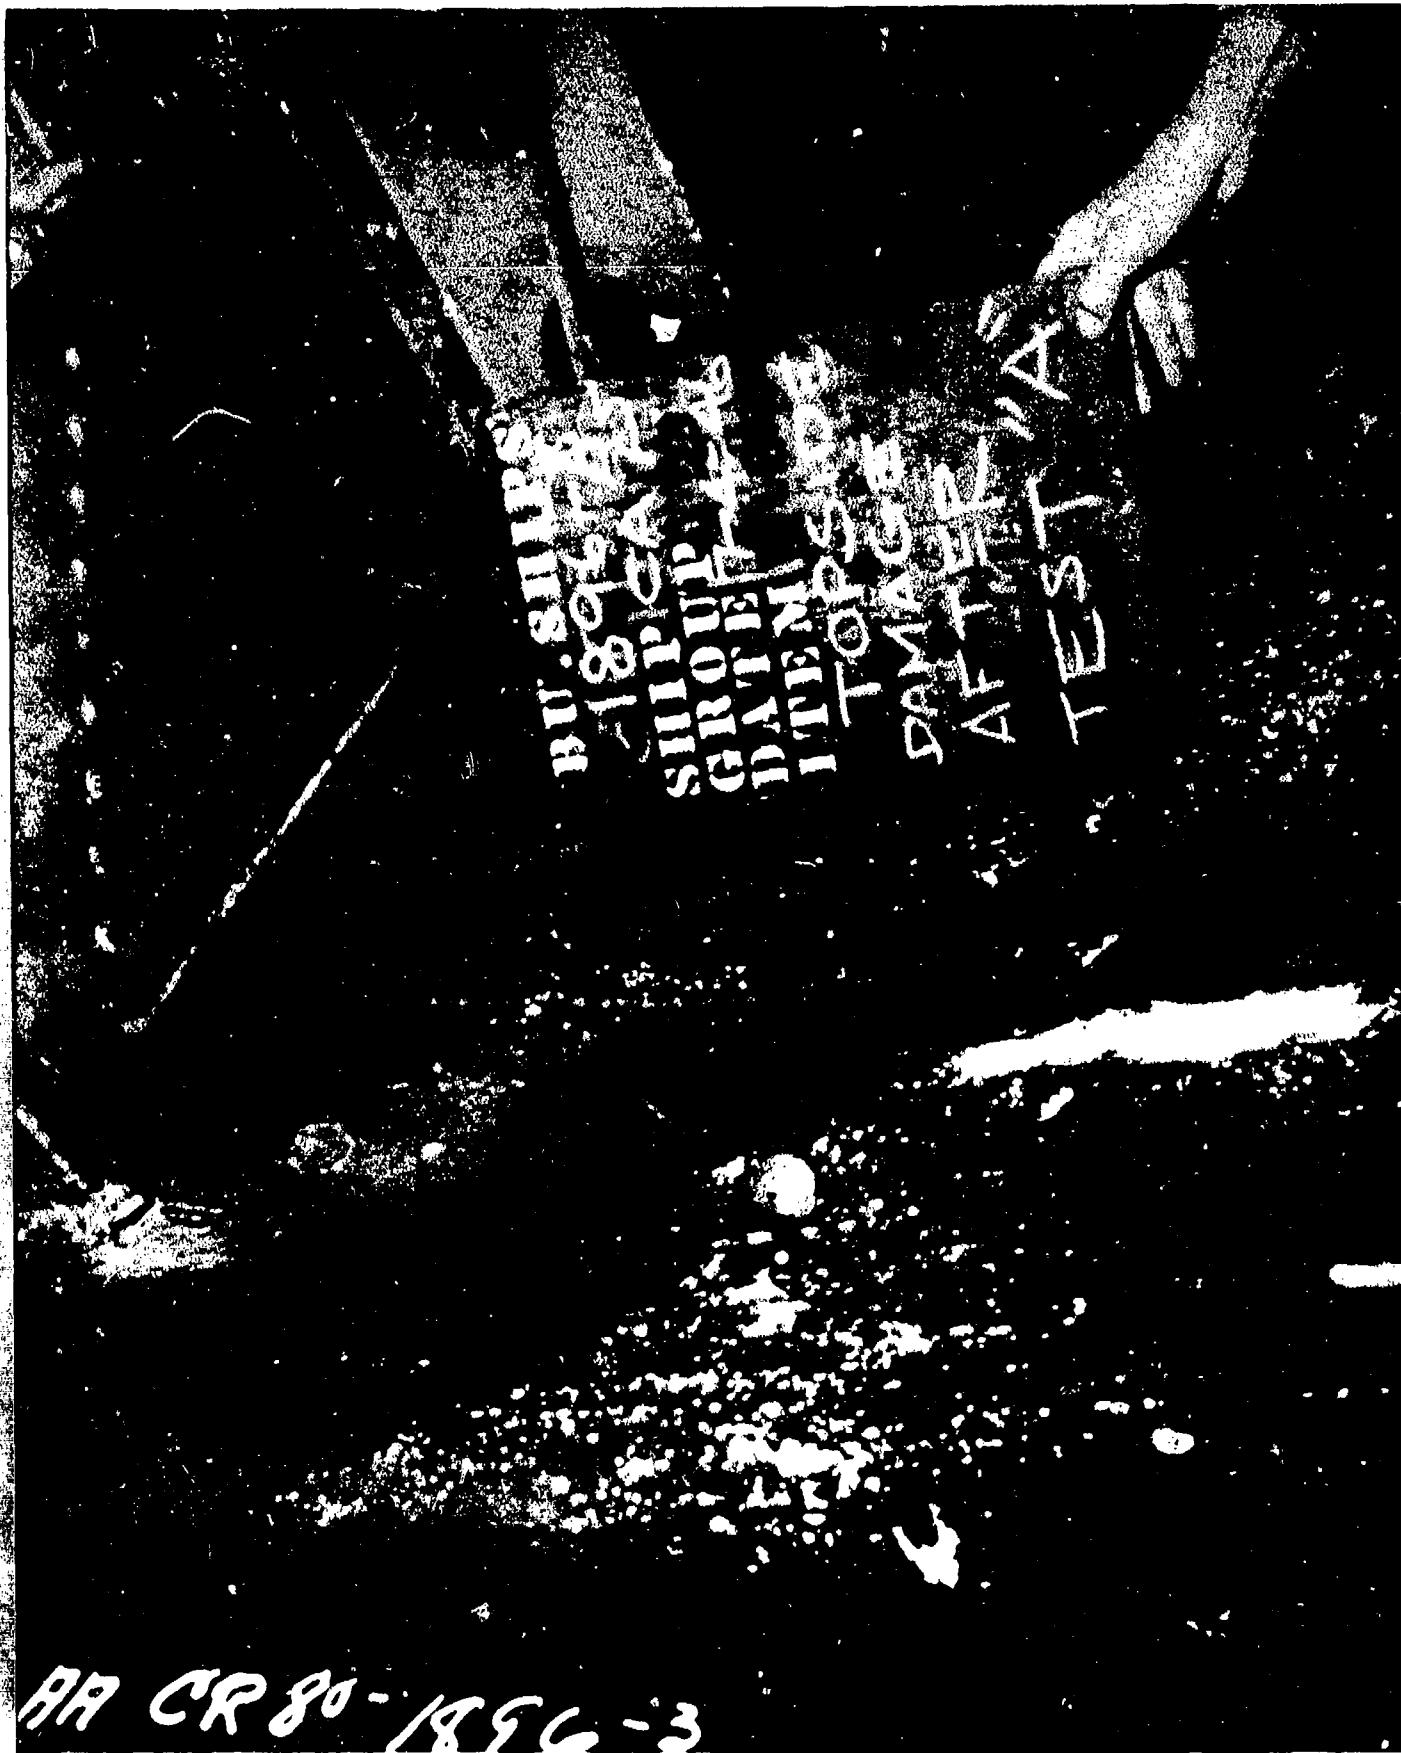
AA CR 80-1896-3

AA-CR-80-1896-3. Failure of plating in way of weld and scorching of
paint on after side of bulkhead 48 on emergency platform.
